Table 2F-1. 3-D Probe Inspection Sheet

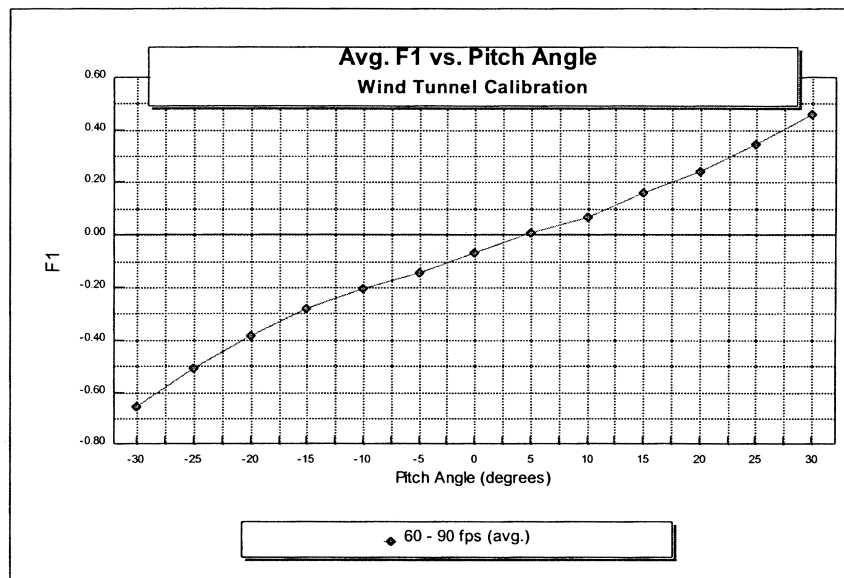
Figure 2F-14. Example F_1 calibration curve for the DAT probe.
